A realistic testing of a shipboard wireless sensor network

H. Kdouh^{1,*}, C. Brousseau², G. Zaharia¹, G. Grunfelder¹ and G. El Zein¹

Abstract—Wireless Sensor Networks (WSN) may be a very useful technology for monitoring systems in hostile environments. Few works have treated the use of this technology in the particular metallic shipboard environment. This paper reports on the deployment of a WSN on board a ferry in realistic conditions. The network was tested during sailings and stopovers for several days. The results of our previous papers reporting on the radio wave propagation on board ships are recalled. Network performance and its topology evolution with respect to previous results are presented. In spite of the metallic structure of ferries and the dynamic movement of crew and passengers on board, the results show a significant network reliability and connectivity. The previous conclusions have been also confirmed by the topology evolution of the network and the analysis of RSSI levels of links between sensor nodes.

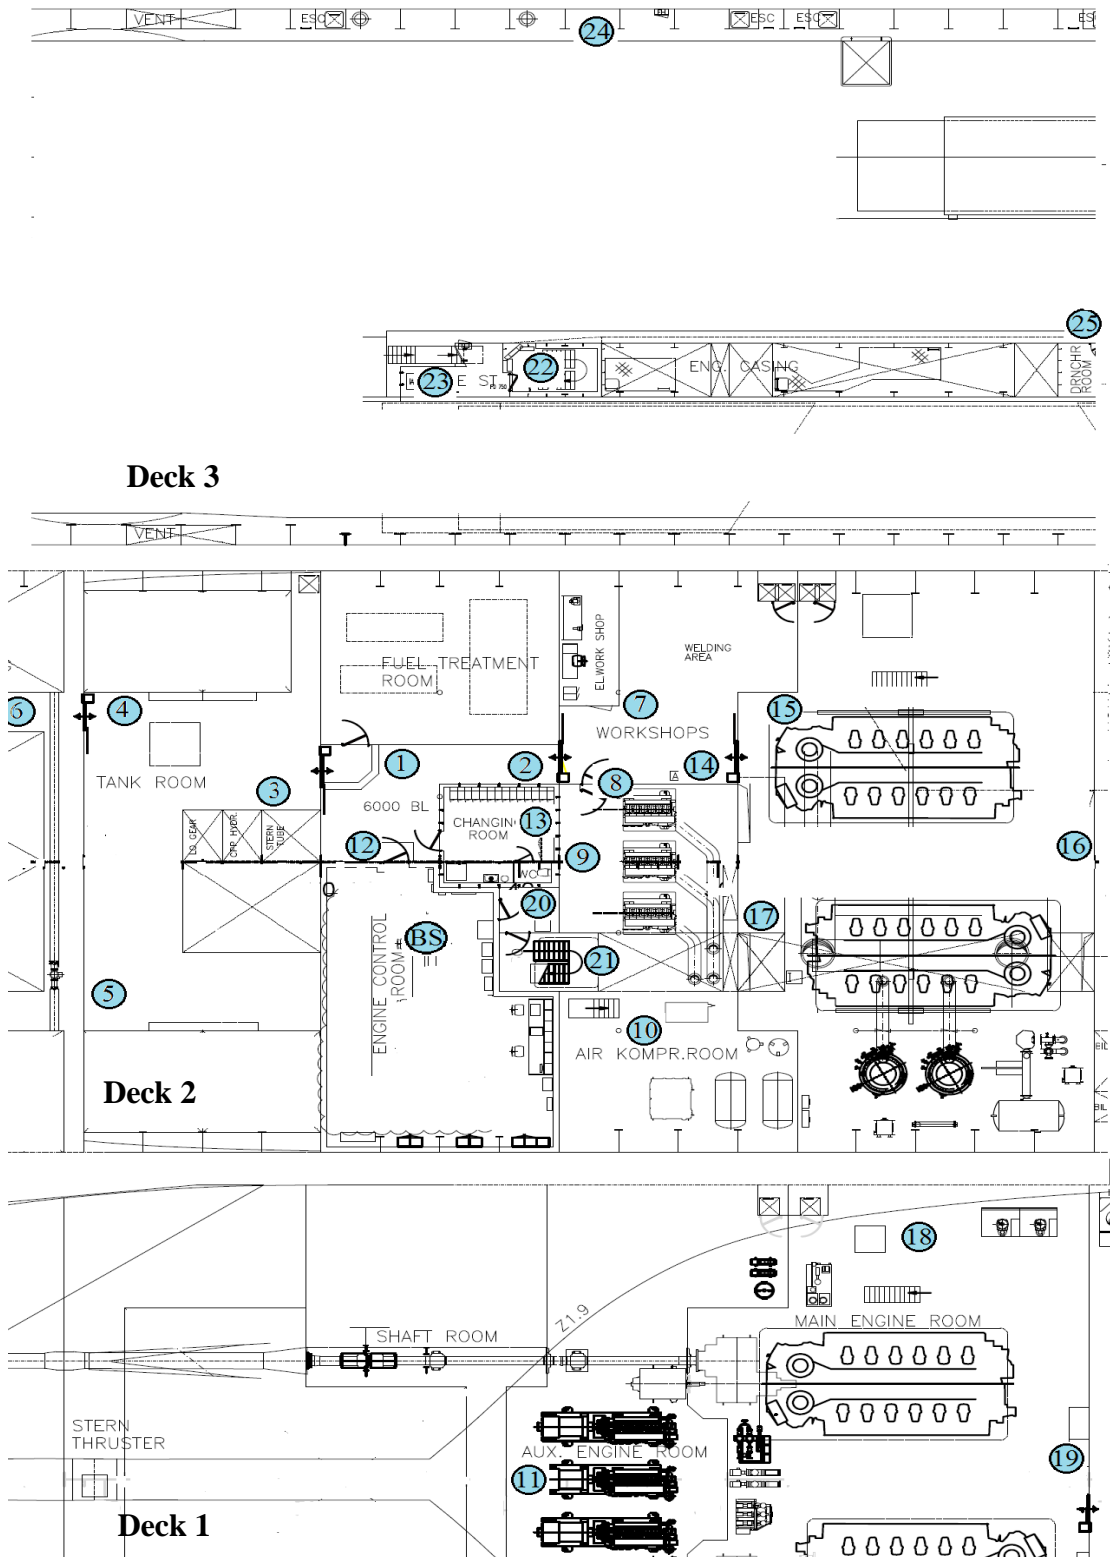
Fig. 2 Locations of the WSN nodes on board “Armorique”.

Previous results show that doors and stairways are the main and probably unique sources for radio leakage between adjacent rooms and adjacent decks respectively. Based on these conclusions, sensor nodes of the WSN on board the “Armorique” are placed in front of doors and in stairways to maintain the connectivity in the network and to provide full radio coverage of studied area.

Although MicaZ nodes have the same capacities and resources, three types of nodes in our deployment may be distinguished according to the node locations: “Stairway” nodes located in the stairway connecting Deck 2 and Deck 3, “hatches nodes” located in front of watertight doors, and “peripheral nodes” located in different rooms near the real sensors of the current monitoring system. The deployed WSN is composed of 25 sensor nodes. Table 1 shows the distribution of nodes between these three defined categories and Fig. 2 shows a planar view of nodes locations on a map of “Armorique”. The gateway node was placed in the control room in Deck 2 and connected to a laptop (running MoteView) via a USB connection.

Category	Nodes
Stairway nodes	20, 21 and 22
Hatches nodes	1, 2, 3, 4, 6, 7, 8, 9, 10, 12, 14, 15 and 23
Peripheral nodes	5, 11, 13, 16, 17, 18, 19, 24 and 25

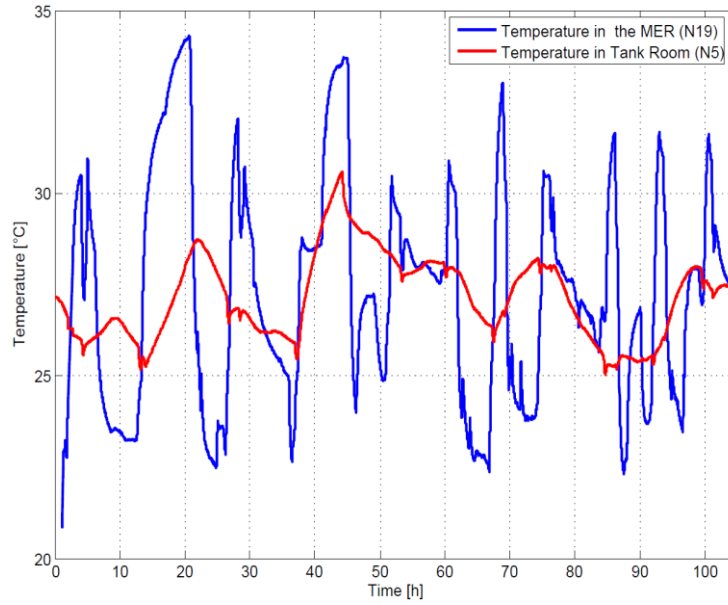
Fig. 3 Time-variation of the temperature (in °C) in MER and the tank rooms.

Fig. 3 and Fig. 4 show the evolution of temperature and vertical acceleration in the tank room and the MER during tests. Blue curves are data sent by node N19 located in the MER and red curves are data sent by node N5 located in the tank room. As shown in Fig. 3, the temperature in the MER increases and decreases alternately. It can be noticed that the temperature in the MER increases during stopovers and decreases during sailings due to the location of N19 near to Air Conditioners (AC) of the MER. AC are used to compensate the increasing of temperature due to the machines in the MER. As these engines are turned off during stopovers, then AC are also stopped. Changes of temperature in the tank room which does not contain engines and AC are smaller and do not depend on the sailings schedule.

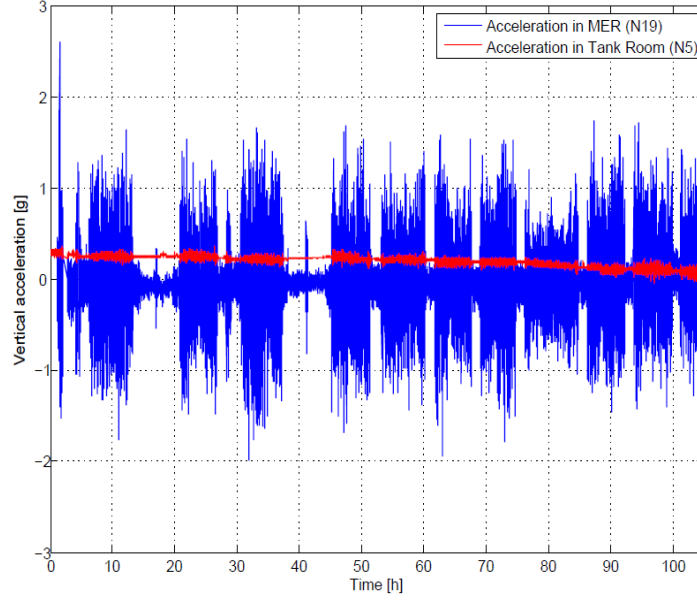
Fig. 4 Time-variation of vertical acceleration (in g) in the MER and the tank rooms.

On the other hand, Fig. 4 shows the evolution of the vertical acceleration in the MER and tank room. The difference between the blue curve (MER) and the red one (tank room) is significant. Vertical acceleration in tank room is almost constant during the test. This value presents some small oscillations during sailings corresponding to vertical motion of the ship in the sea. However, the difference between sailings and stopovers is more significant in the MER. Machines oscillations in the MER during sailings cause this big difference between values of vertical acceleration in the two periods.

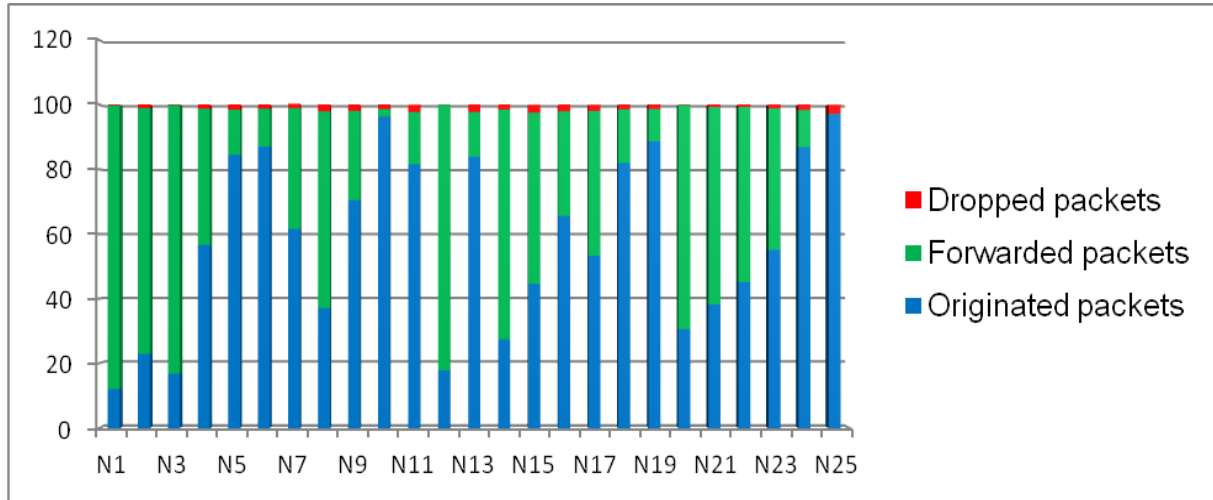
Fig. 5 Percentage of dropped, forwarded and originated packets for each node after the network test on board “Armorique”.

Fig. 5 shows the percentage of originated packets, forwarded packets and dropped packets for each sensor node. Originated packets include all data, node health; neighbor health and route update packets originated by the node. Health packets contain information about how well the mote is performing in the mesh network, specifically radio traffic. Other health packet information includes battery voltage and the parent's RSSI data. Forwarded packets are the packets that the node has forwarded from other nodes. Dropped packets are the packets that the node has dropped. According to the XMesh protocol, packets are considered to have been dropped when a packet has been retransmitted 8 times without receiving the acknowledgement.

The results of Fig. 5 show that more than 97% of data packets have successfully arrived to the base station, which reflects a significant reliability of the network. Results indicate also that the percentages of forwarded packets were high for nodes N1, N2, N3, N4, N7, N9, N10, N12, N14, N15, N16, N17, N20, N21, N22 and N23 (hatches and stairways nodes). These nodes were located near the watertight doors and in the stairways in order to route sensing data coming from rooms. Among these routers, N1, N2, N3, N12 and N20 have the maximum values of forwarded packets. This is explained by their locations in the radio range of the gateway node.

Although the dynamic environment on board "Armorique", we can clearly remark that movement of persons (passengers and crew members) and objects (frequent door closing, charge and discharge of parking, etc.) did not affect the reliability of the network (in terms of packet delivery ratio). This shows the constructive aspect of the metallic shipboard environment, which creates multiple propagation paths for the radio waves, and allows the successful arrival of data packets even if the Line-of-Sight is blocked. Moreover, stairway nodes have been selected as parent nodes by peripheral nodes in the parking. Hatches nodes are also selected by peripheral nodes. This confirms the previous conclusion saying that paths followed by data packets are predictable.

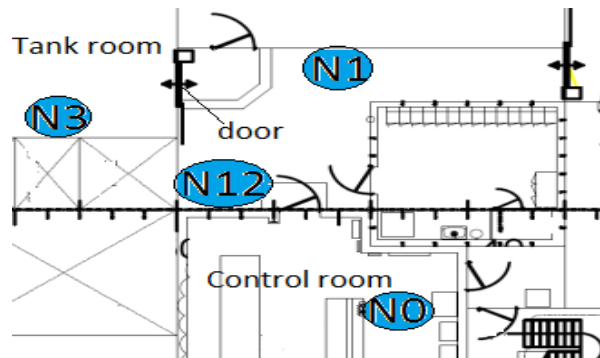
Fig. 6 N3 and its parent nodes.

We tried to close the maximum number of watertight doors during the test to simulate the worst case. However, some doors remained opened by the crew members. Therefore, some connections between nodes separated by more than one watertight door have been detected. Previous results have shown that two nodes separated by two closed watertight doors cannot communicate. For example, node N3 has selected the gateway node N0 as its parent node for 76 % of packets and nodes N1 and N12 for the remaining packets (Fig. 6). Establishment of links N3-N1 and N3-N12 is coherent, since the two sides of these connections are separated by only one watertight door. However, the connection between N3 and N0 is not possible if the watertight door of between the tank room and the control room was maintained closed.

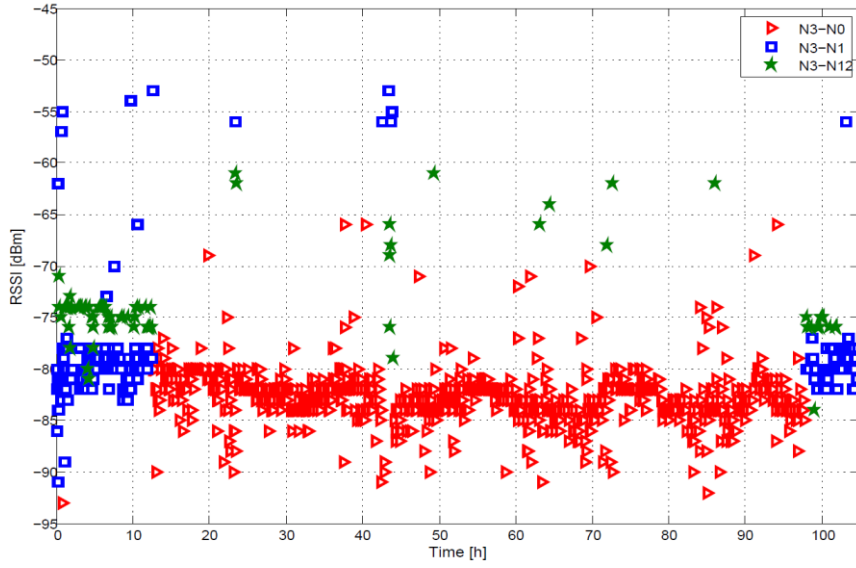
Fig. 7 Time-evolution of RSSI (in dBm) for the links between N3 and its parent nodes.

To verify the existing configuration when this link was established, the evolution of RSSI corresponding to links between N3 and its parent nodes is studied. Fig. 7 shows its time-evolution. It can be seen that N3 has selected N1 or N12 until $t = 12$ hours and it switches to N0 between $t = 12$ and $t = 99$ hours when it re-switches to N1 or N12. In addition, most of RSSI values corresponding to link N3-N1 are grouped around a mean value of -80 dBm. Some values increase to -55 dBm after $t = 12$ hours. N1 and N3 are separated by one door. The gap of 25 dB between the two levels of RSSI corresponding to link N3-N1 represents the power loss due to the closing of this door. The status of this door (opened or closed) can be simply determined by seeing the RSSI level of N3-N1. It can be noticed that N3 has switched to N0 when the door was opened and link N3-N0 remains established until the door closure at $t = 100$ hours. Therefore, when N0 was the parent node of N3, only one door (control room door) was closed and link N3-N0 has stopped when the second door was closed. It is also worth mentioning that

most of RSSI values of link N3-N0 are grouped around a mean value of -83 dBm. Some values reach -65 dBm. This gap of 18 dB is due to the opening of the control room door.

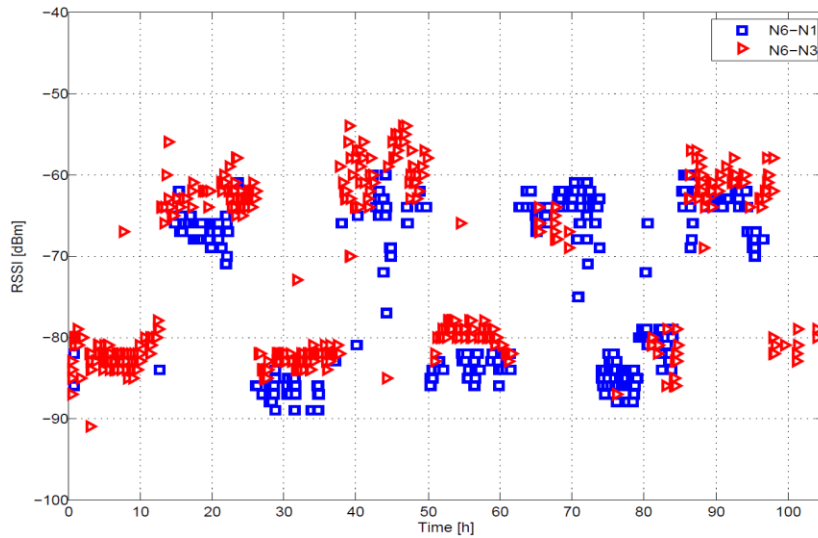
Fig. 8 Time-evolution of RSSI (in dBm) for the links between N6 and its parent nodes.

Although we tried to maintain most of watertight doors closed, the status of several doors has frequently changed during the measurement test. The analysis of RSSI measurements between the pairs of sensor nodes located in different rooms allows estimating the supplementary path loss due to the watertight door closure. For example, node N6 has mainly selected N3 and N1 as its parent nodes. The common watertight door between the tank room and the rudder gear room is placed on the direct path N6-N3. Similarly, as shown in Fig. 2, the watertight door between the tank room and “6000BL” room is placed on the direct path N6-N1. Fig. 8 shows the RSSI measurements of links N6-N1 and N6-N3. It can be seen that these two links have the same behavior with a slowly higher level of N6-N1. The little difference between RSSI levels proves that the watertight door of “6000BL” room was opened when N6-N1 was established. Therefore, the gap between the two main levels of RSSI in Fig. 8 corresponds to the excess path loss due to the closing of the door between the rudder gear room and the tank room. The link N6-N3 has an upper level with a mean value of -60 dBm and a lower level with a mean value of -84 dBm, which leads to an excess path loss of 24 dB. Similarly, the link N6-N1 has an upper level of -65 dBm and a lower level of -88 dBm, which leads to an excess path loss of 23 dB.

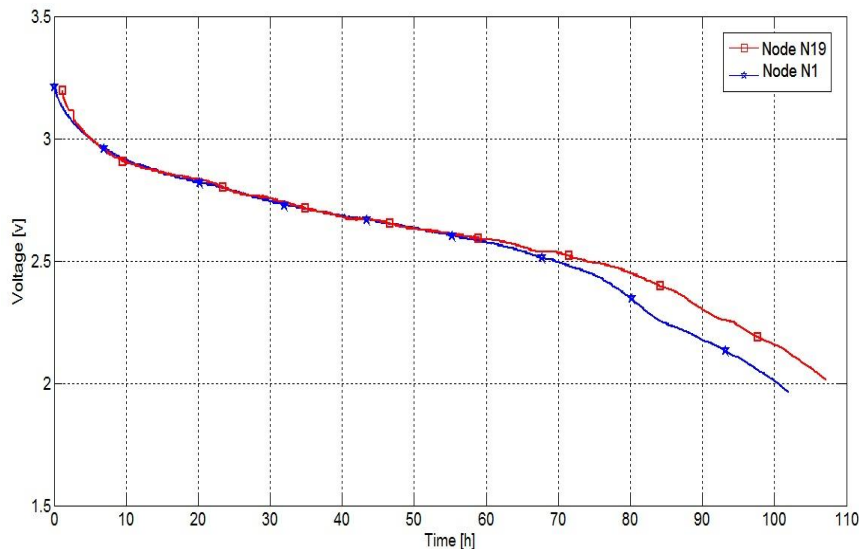
Fig. 9 Time-evolution of the voltage for nodes N1 and N19.

Although the high power consumption mode of XMesh was used, the evolution of power consumption of sensor nodes during the network test has been studied. The objective is not to determine the power consumption of nodes, but to compare the voltage evolution of peripheral and critical nodes. It is expected that power consumption of critical nodes such as N1, N3 and N20 will be clearly greater than that of peripheral nodes such as N18, N19 and N25. However, results indicate a small difference between power consumptions. The voltage drops of nodes N1 and N19 are depicted in Fig. 9. N1 and N19 have similar number of originated packets, but N1 has forwarded a number of packets 65 times greater than that forwarded by N19. Since the transmission and reception are the two main factors that increase the power consumption of a sensor node, N1 must have a greater consumption and it will die before N19. Nevertheless, **Fig. 9** indicates a slightly larger power consumption and a slightly shorter lifetime for N1. This similarity may be explained by the overhearing problem, by which nodes waste energy in receiving all packets that are transmitted in their neighborhood even if they are intended for other nodes. Another factor may be the small route updates interval time where sensor nodes consume energy in collecting health data about their neighbors. A power control mechanism must be developed in order to enlarge the shipboard WSN lifetime. As sensor nodes send their sensing data mainly via hatches nodes or stairway nodes (critical nodes) and the links established have shown good stability and quality, it will be useful to reduce the route updates frequency to save energy.
